Handover Inspection Report

A401 / 42–58 Nelson Street,
Ringwood, VIC 3134

Issue Schedule	
Issue Date:	Issued by:
February 2019	Yoyo Haigh

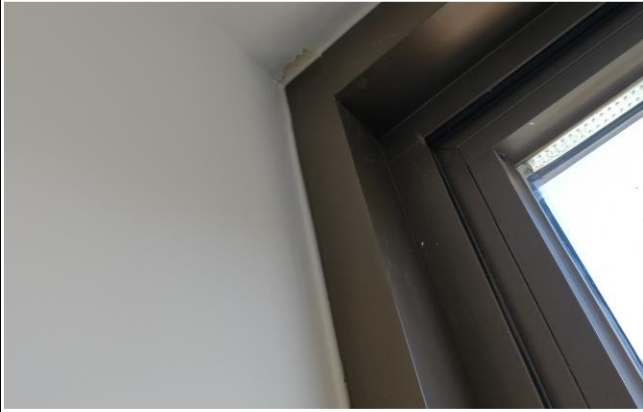
<p>Item No: 1 Location: Bedroom window Description: Dirty at the top Recommendation: Remove dirt and clean up.</p>

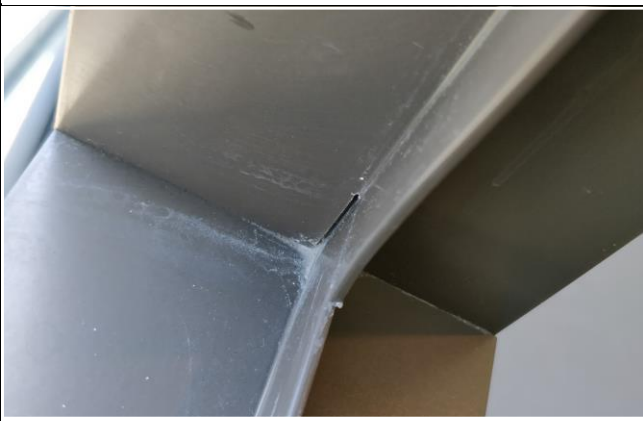
<p>Item No: 2 Location: Window frame Description: Gap at the frame Recommendation: Fill and touch up paint.</p>

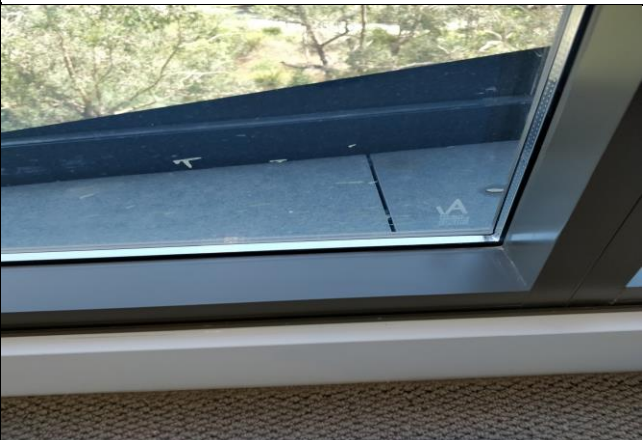
<p>Item No: 3 Location: Window Description: Scratch and dirt on glass Recommendation: Remove dirt and clean up the glass.</p>

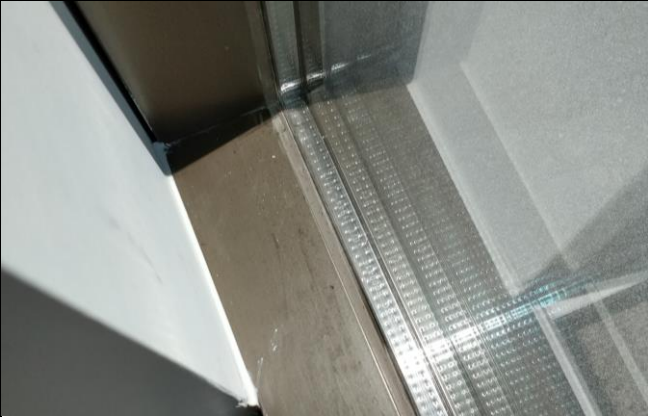
<p>Item No: 4 Location: Bedroom window Description: Too much paint in the corner Recommendation: Remove the excess paint.</p>

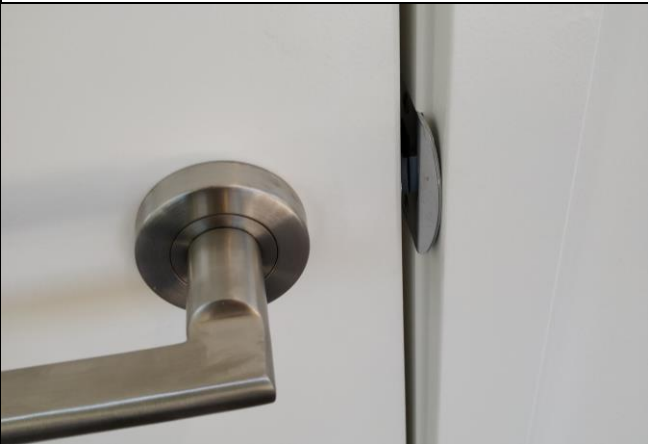
<p>Item No: 5 Location: Bedroom door Description: Door does not close properly Recommendation: Check for door latch and hinge, tighten the screws.</p>

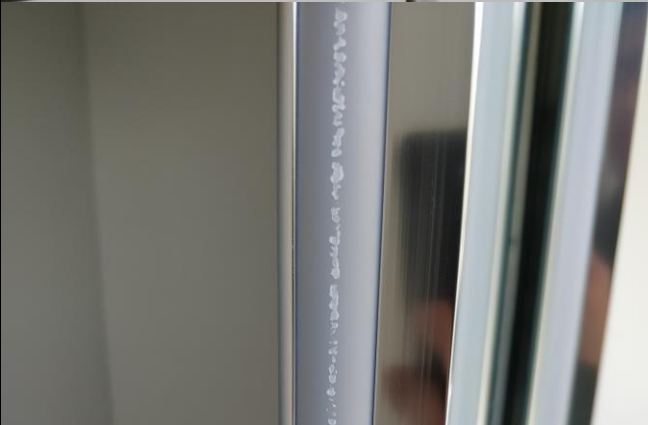
<p>Item No: 6 Location: Wardrobe Description: Excess paints on the wardrobe frame Recommendation: Paints need to be cleaned.</p>

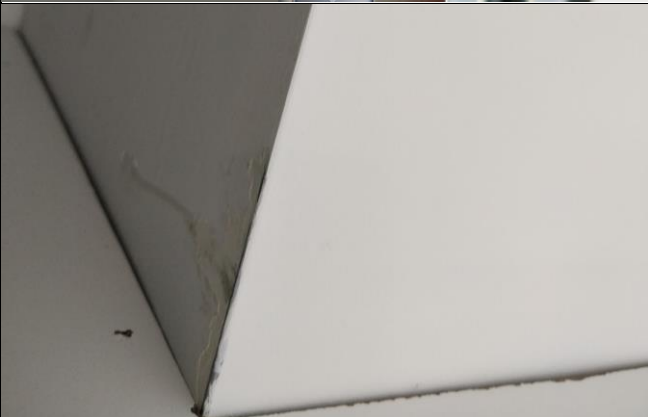
<p>Item No: 7 Location: Wardrobe Description: Crack inside the wardrobe Recommendation: Fix the cracked part and make good surface</p>

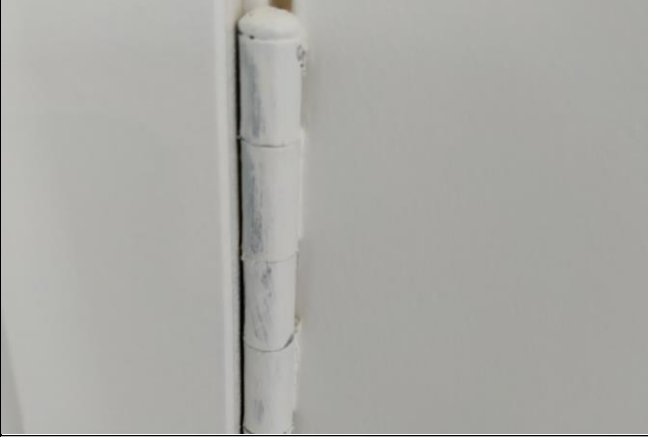
<p>Item No: 8 Location: Bedroom door Description: Missing paint Recommendation: Touch up paint.</p>

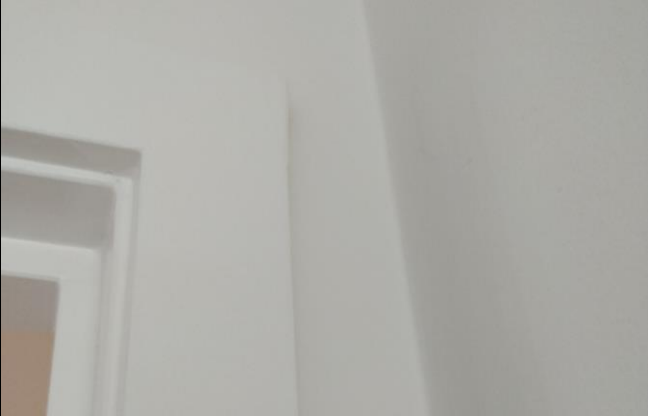
<p>Item No: 9 Location: Bedroom doorframe Description: Not straight at protruding area Recommendation: Fix the frame and make good surface.</p>

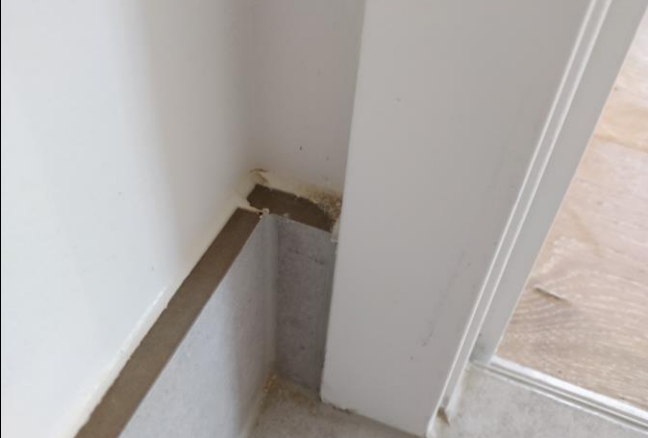
<p>Item No: 10 Location: Corner of the bathroom Description: Dirt in the wall corner Recommendation: Remove dirt and clean up.</p>

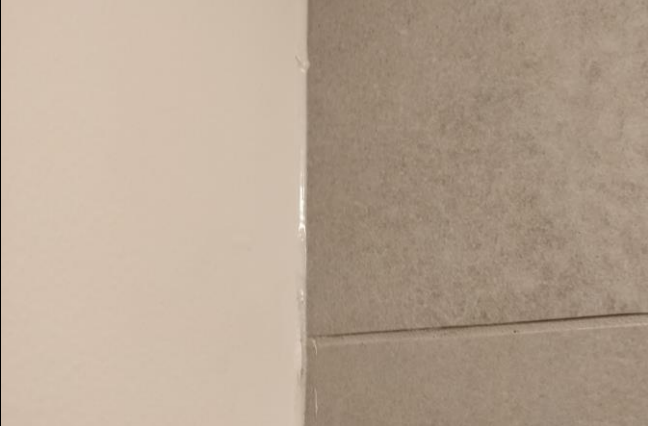
<p>Item No: 11</p> <p>Location: Joint between tile and painting</p> <p>Description: Excess paint</p> <p>Recommendation: Remove the excess paint and clean up.</p>
---	---

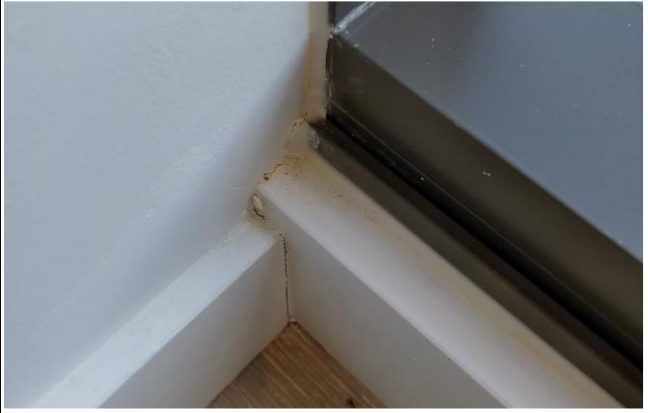
<p>Item No: 12</p> <p>Location: Corner near the window</p> <p>Description: Gap and crack in the corner</p> <p>Recommendation: Fill the gap and fix the crack with touch up paint.</p>

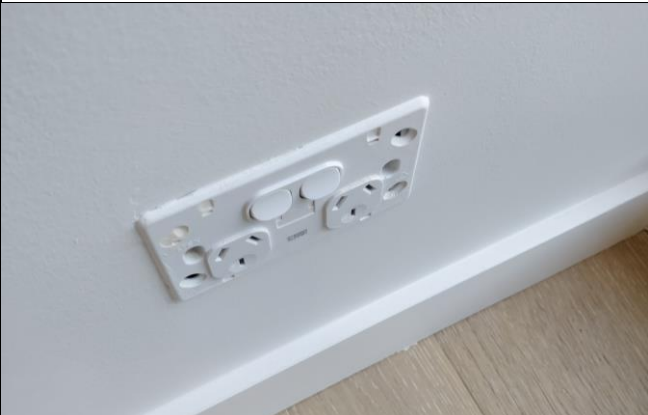
<p>Item No: 13</p> <p>Location: Socket on the wall</p> <p>Description: Missing socket cover</p> <p>Recommendation: Put on the socket cover.</p>

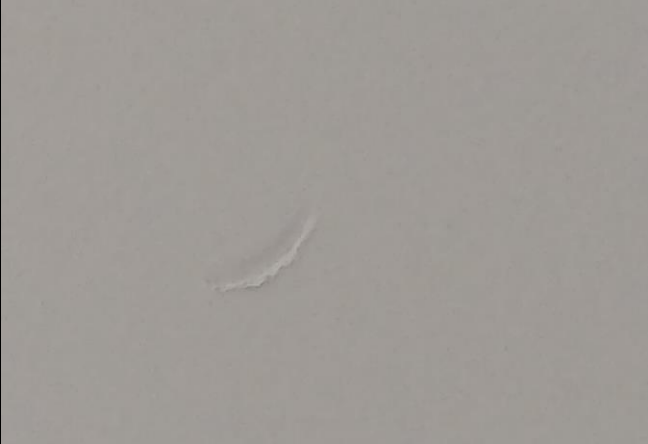
<p>Item No: 14 Location: Living room ceiling Description: Crack on the ceiling Recommendation: Fill and touch up paint.</p>

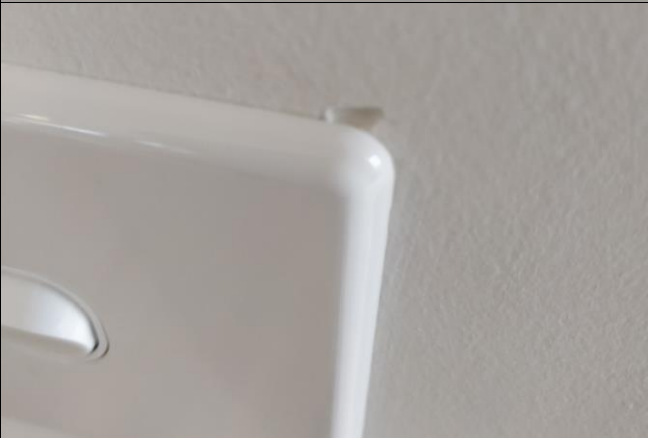
<p>Item No: 15 Location: Light switch panel Description: Crack on the wall. Recommendation: Fill and touch up paint.</p>

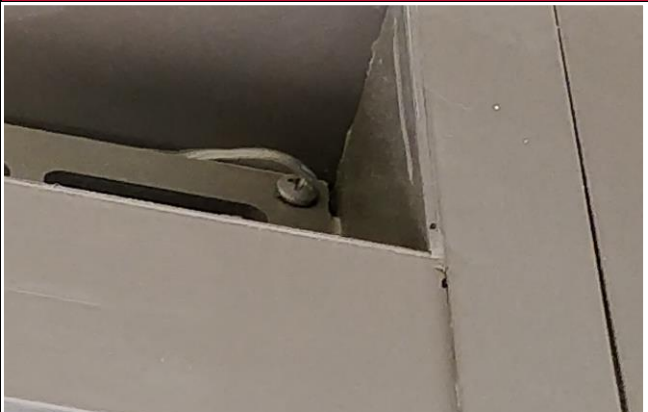
<p>Item No: 16 Location: External door of the property Description: Protruding on the door Recommendation: Needs painting.</p>

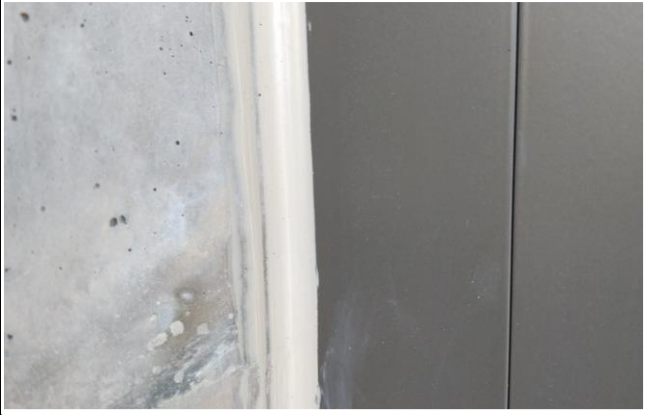
<p>Item No: 17 Location: External Side of Property Description: Dirt and excess paint Recommendation: Remove the excess paint and the dirt</p>

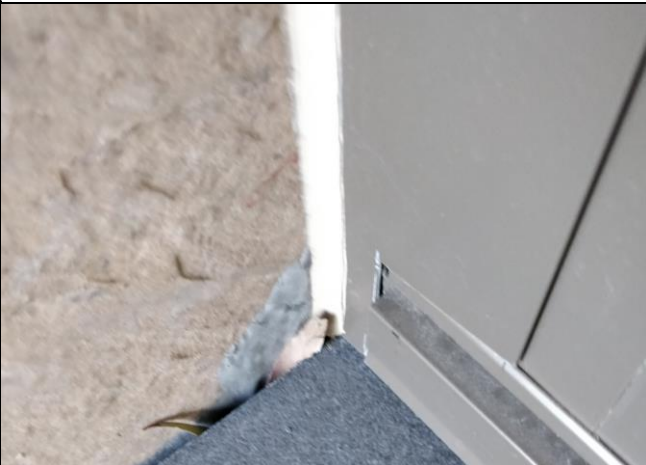
<p>Item No: 18 Location: External Wall Description: Painting coming off Recommendation: Repaint and fill the gap.</p>

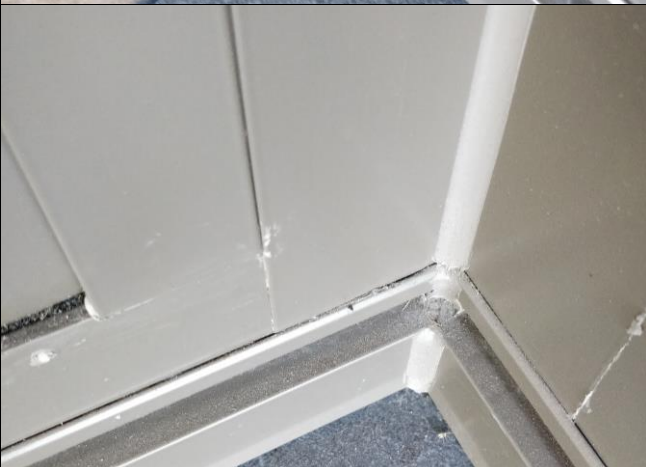
<p>Item No: 19 Location: External Wall Description: Dirty and crack on the wall. Recommendation: Fill the crack with touch up paint and remove the dirt.</p>

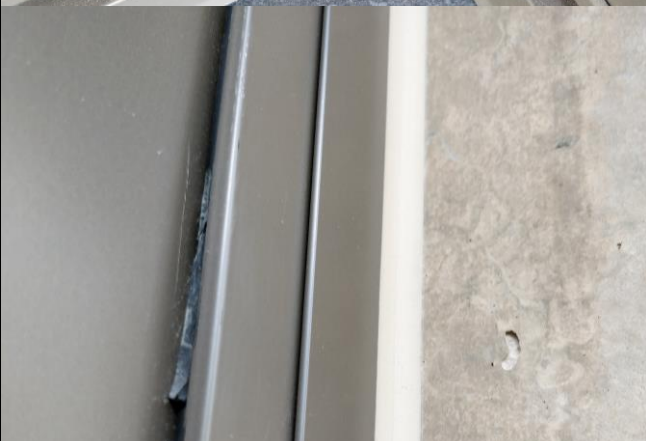
<p>Item No: 20 Location: Exterior door Description: Extra waterproof plastic and dents on the wall. Recommendation: Remove the excess part, fill the dent and make good surface.</p>

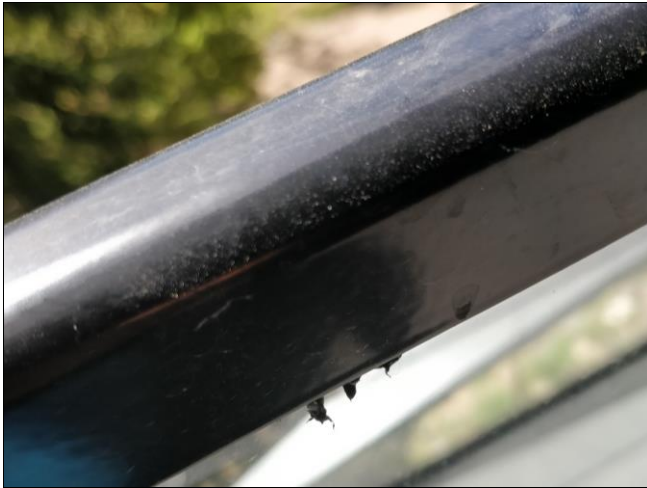
Item No: 21
Location: Exterior railing
Description: Rubber grip peeling off.
Recommendation: Replace with new rubber grip and make good surface.

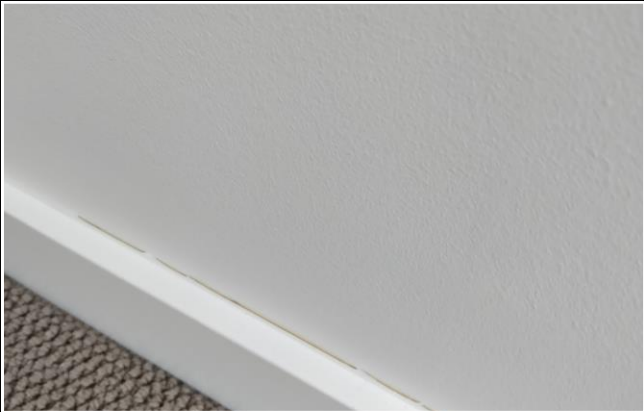
Item No: 22
Location: Bottom of the wall
Description: Gap between wall and skirting
Recommendation: Fill the gap with touch up paint.

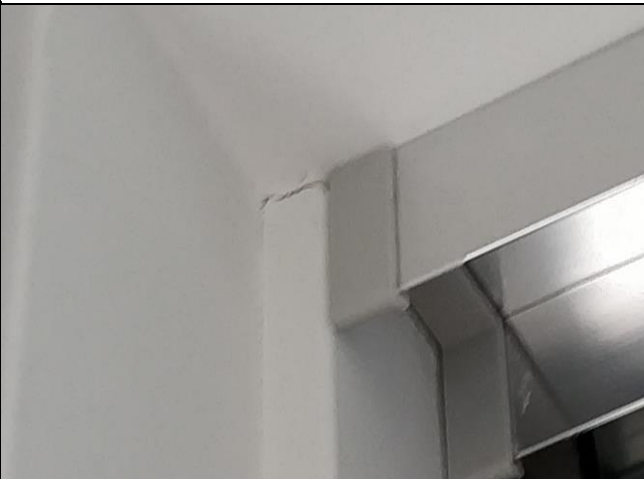
Item No: 23
Location: Top of the wall
Description: Crack on the top
Recommendation: Fill the crack with touch up paint.

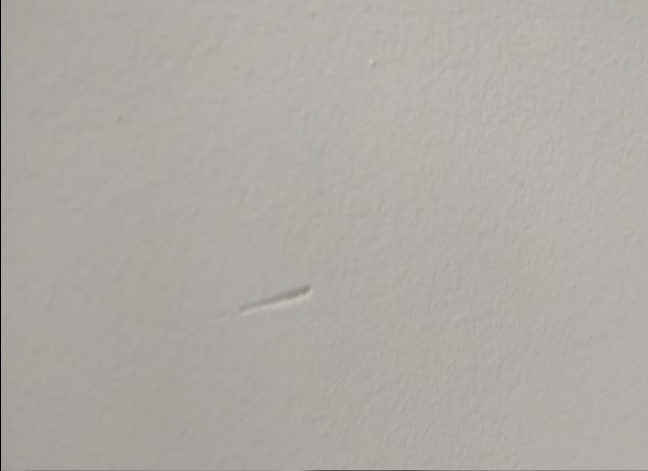
<p>Item No: 24 Location: Wall Description: Scratch on the wall Recommendation: Fill the scratch with touch up paint</p>

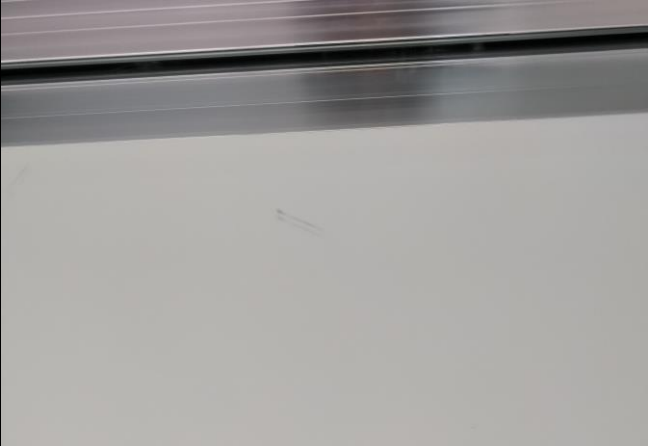
<p>Item No: 25 Location: Mirror Description: Scratch on the mirror Recommendation: Remove the scratch and clean up.</p>
 	<p>Item No: 26 Location: Bedroom wall Description: Paint marks on the wall Recommendation: Remove the mark and touch up paint.</p>
 	<p>Item No: 27 Location: Bedroom wall Description: Cracks and dirty on the wall Recommendation: Remove the dirt and fill the crack with touch up paint.</p>

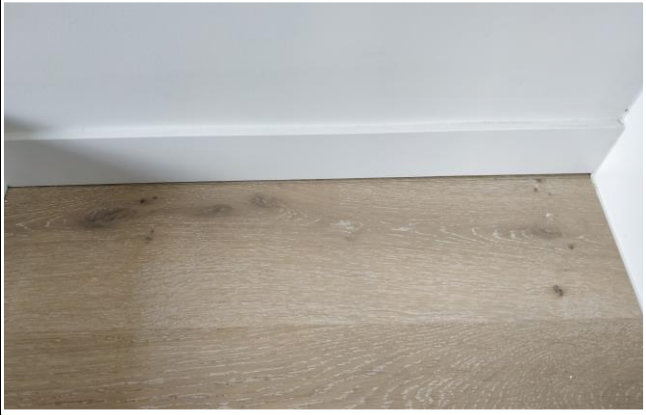
<p>Item No: 28</p> <p>Location: Kitchen skirting</p> <p>Description: Not level and there is a gap between the skirting and the floor</p> <p>Recommendation: Fill the gap, touch up paint and make good surface.</p>

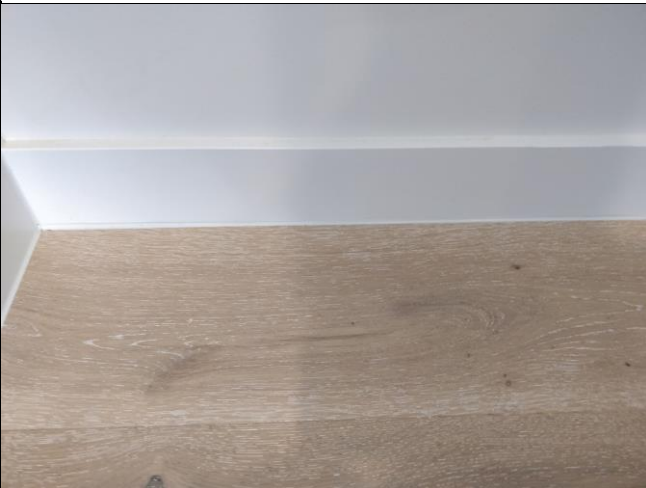
<p>Item No: 29</p> <p>Location: Kitchen skirting</p> <p>Description: Not straight</p> <p>Recommendation: Fix and touch up paint to make it straight.</p>
